# Phase V Status Report No. 5 and Remedial Monitoring Report No. 20

50 Tufts Street, Somerville, Massachusetts

February 10, 2014

Project 04516-3

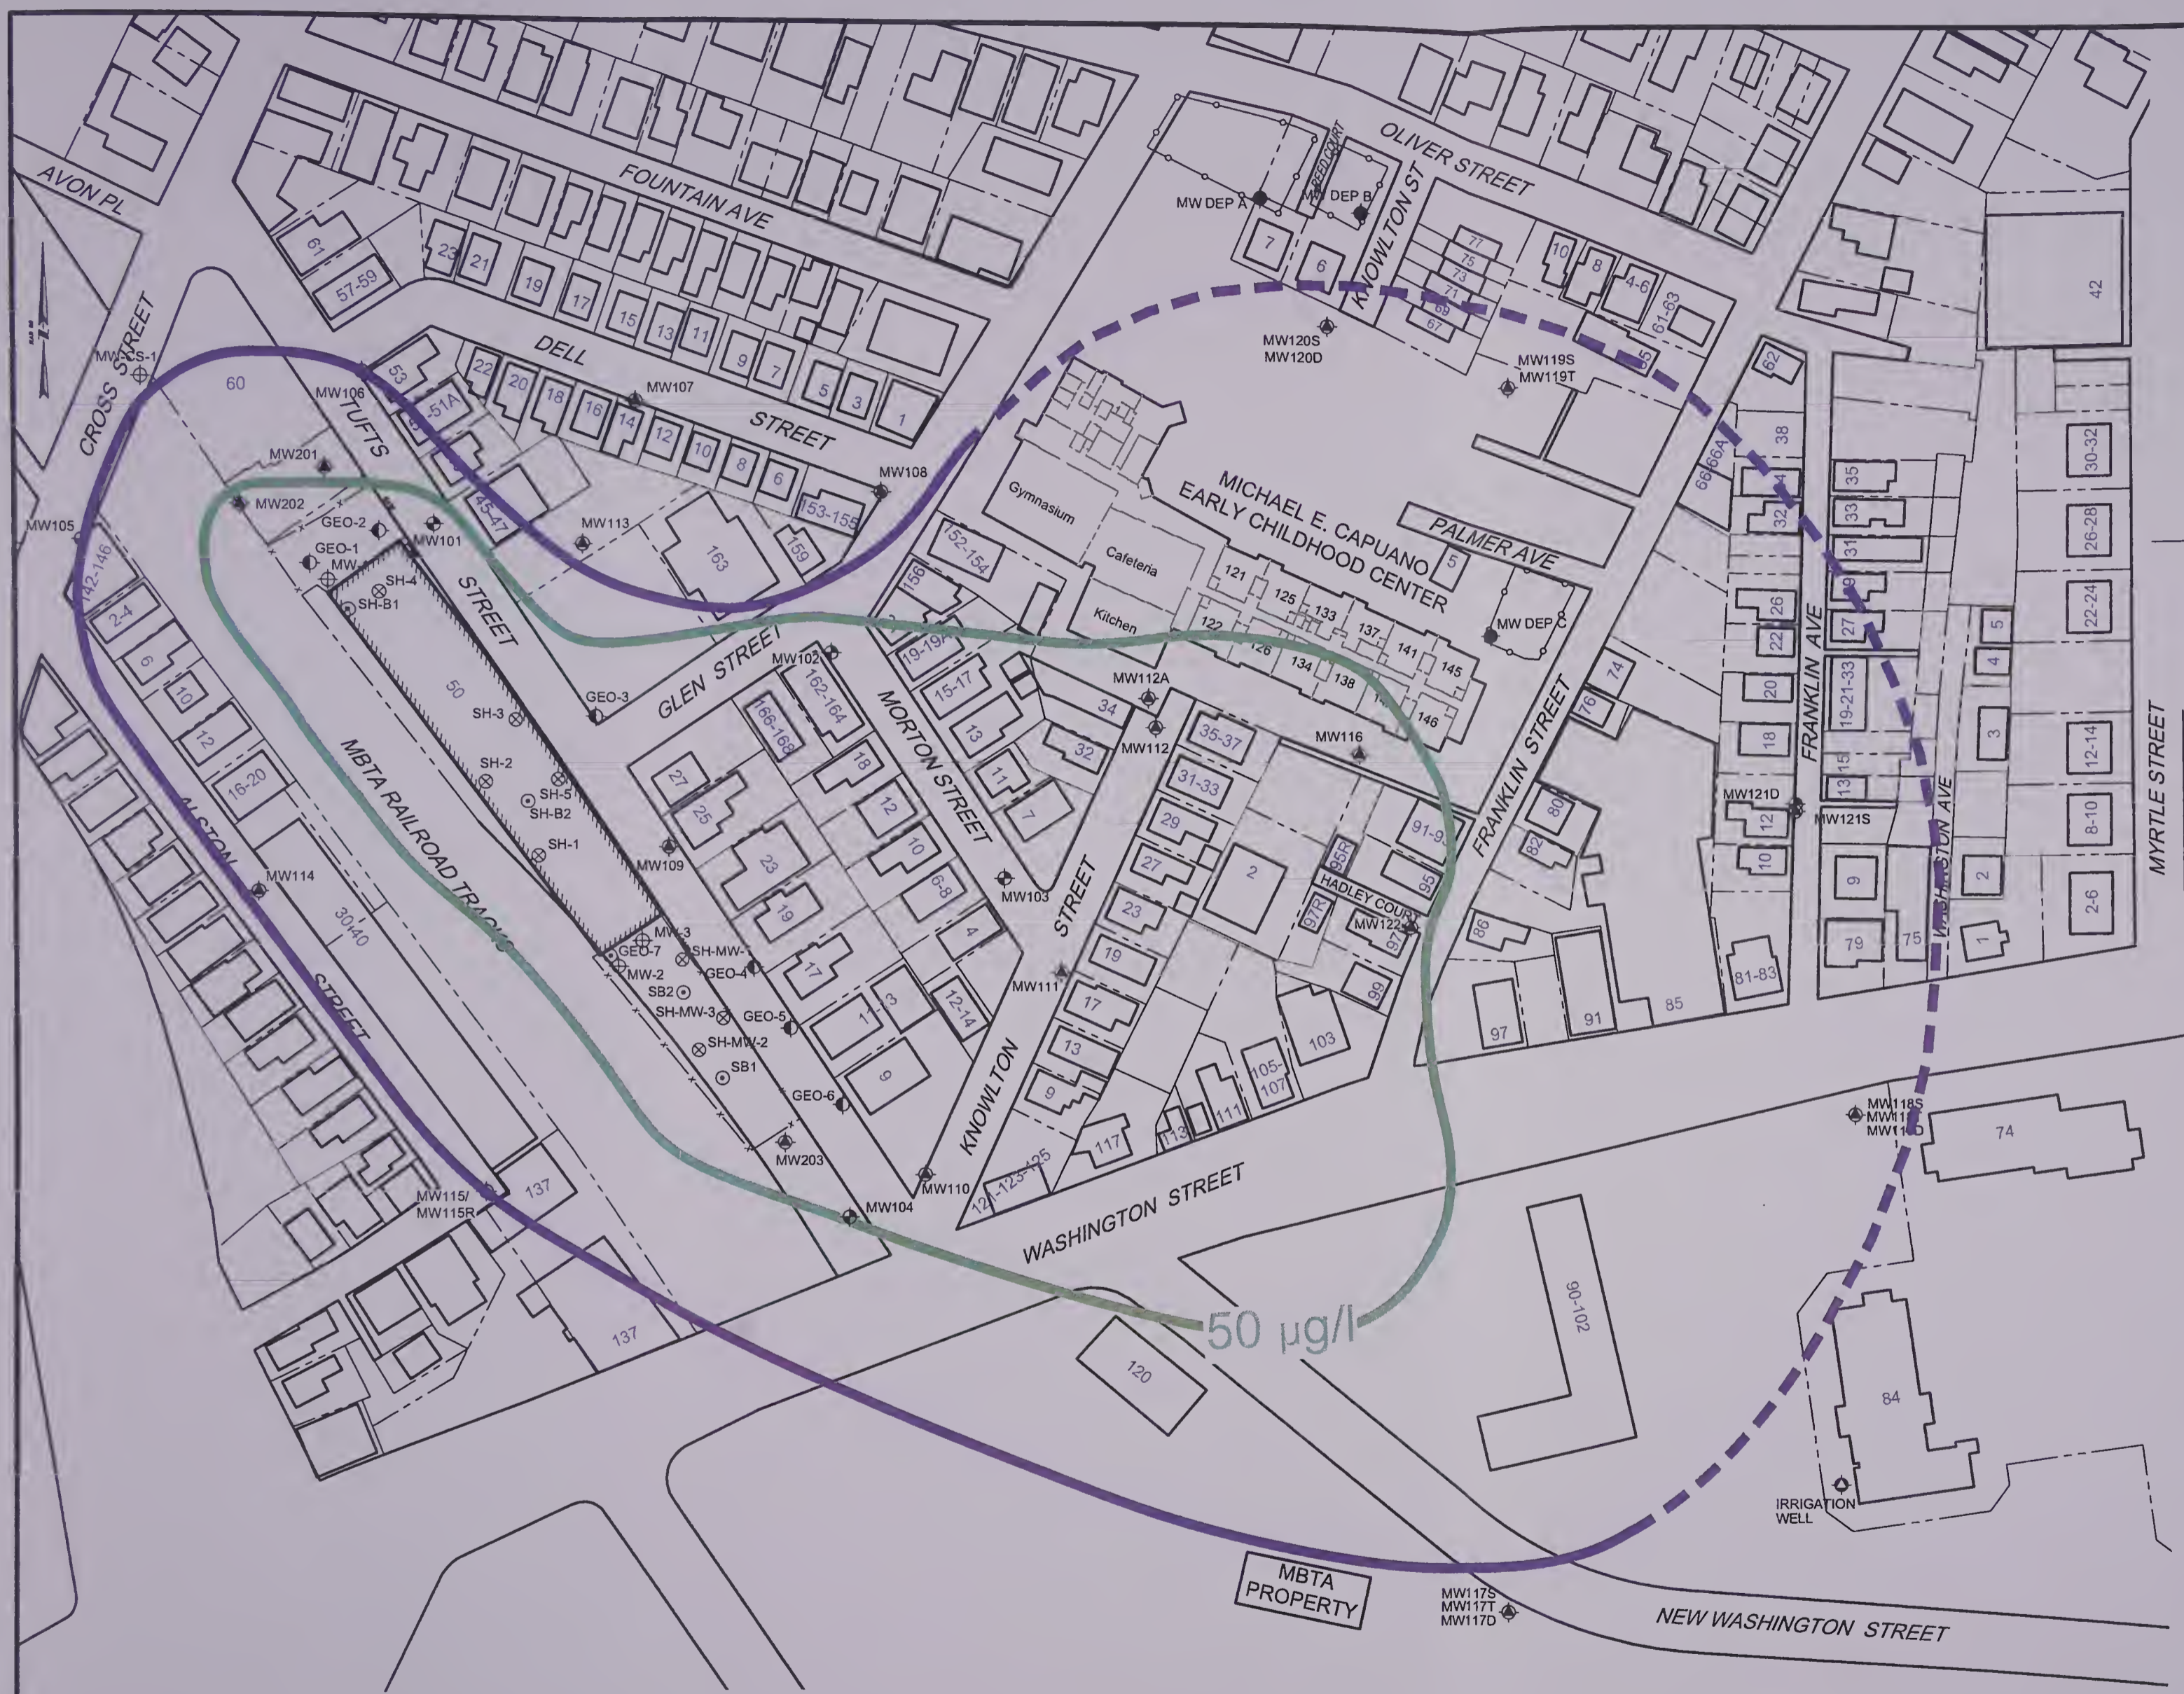
DISPOSAL SITE MAP  
AND  
SITE BOUNDARY  
February 2014  
Fig. 1-2

- MONITORING WELL WITH SOIL VAPOR SAMPLE PORT INSTALLED BY GEI, JANUARY 2007 - JANUARY 2008
- MONITORING WELL INSTALLED BY SANBORN HEAD ASSOCIATES, 2002
- MONITORING WELL INSTALLED BY GEOSIGHT, JUNE 2004
- SOIL BORING ADVANCED BY GEOSIGHT, AUGUST 2004
- MONITORING WELL INSTALLED BY GEI, MAY 2006
- DRIVEN POINT MONITORING WELL INSTALLED BY MADEP, MAY 2007
- MONITORING WELL INSTALLED PREVIOUSLY, DATE UNKNOWN
- PREVIOUSLY INSTALLED IRRIGATION WELL
- CHAIN LINK FENCE
- 138 ROOM NUMBER AT CAPUANO SCHOOL
- BOUNDARY OF COMMUNITY GARDENS
- 84 STREET ADDRESS
- MBTA = MASSACHUSETTS BAY TRANSPORTATION AUTHORITY
- DISPOSAL SITE BOUNDARY (DASHED WHERE INFERRED)
- EXTENT OF PCE CONCENTRATION IN GROUNDWATER GREATER THAN OR EQUAL TO 50 µg/l.
- µg/l = MICROGRAMS PER LITER

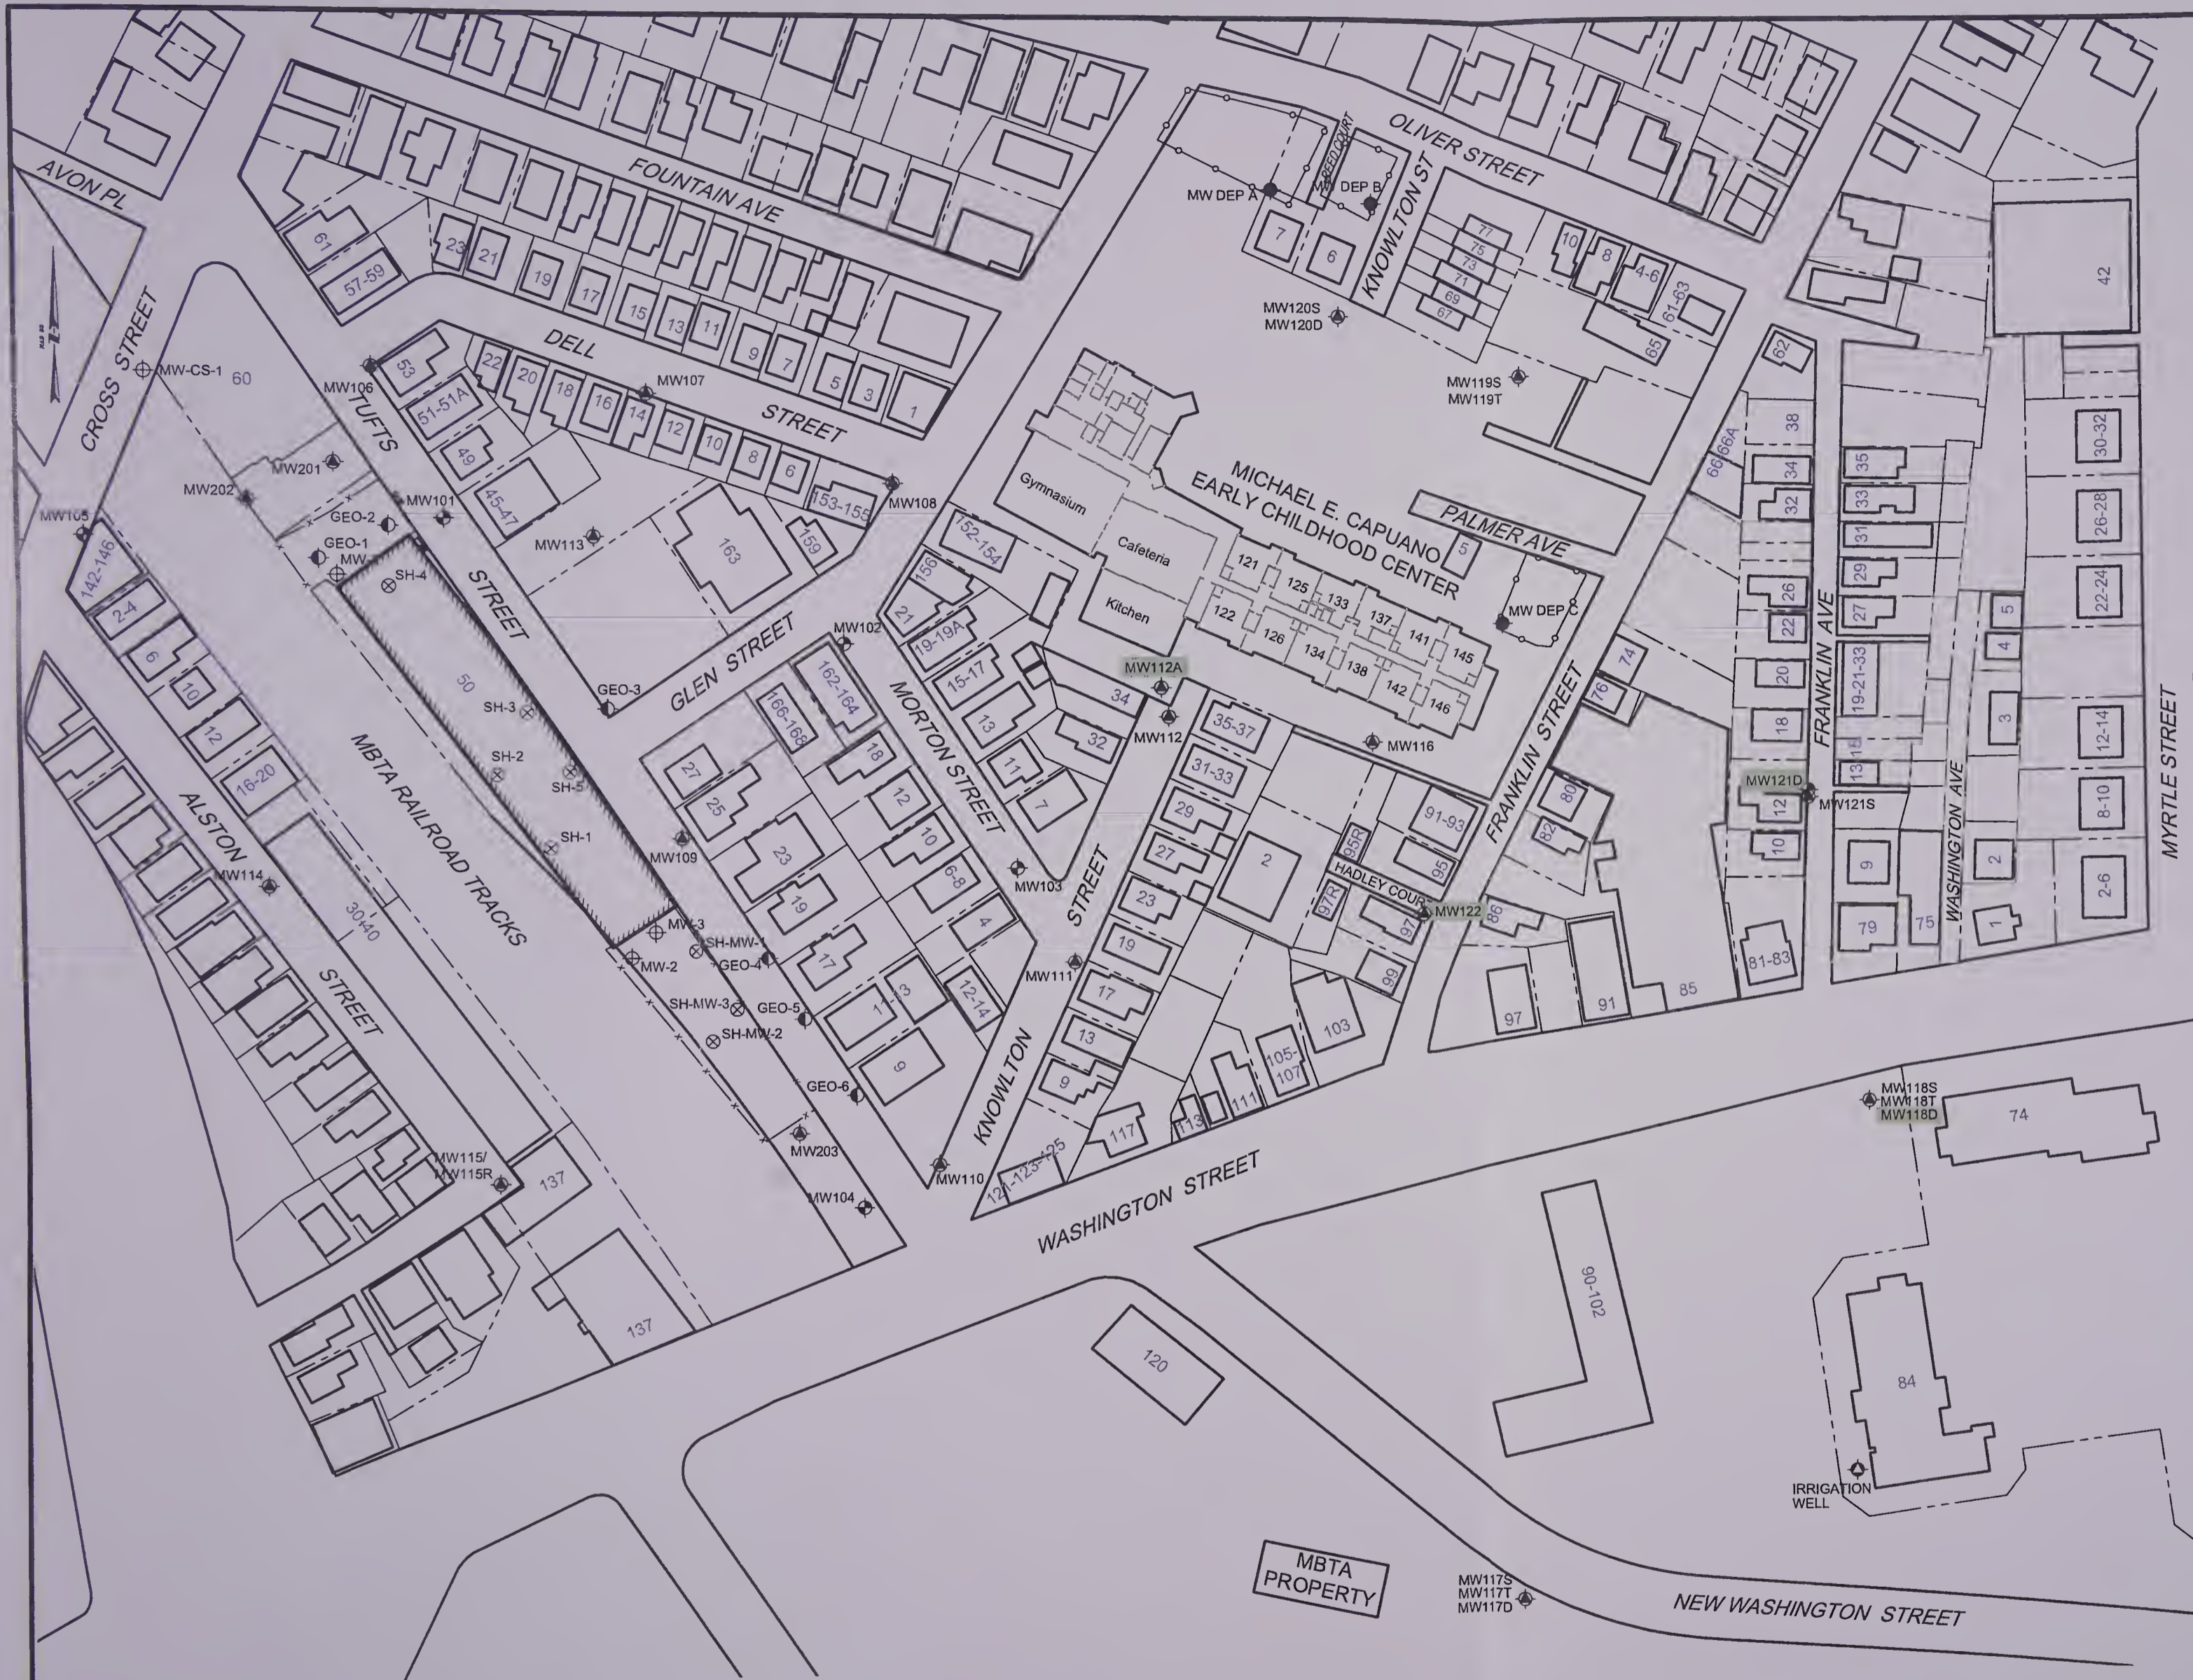
Phase V Status Report No. 5 and Remedial Monitoring Report No. 20 50 Tufts Street, Somerville, Massachusetts UniFirst Corporation Wilmington, Massachusetts	 <b>MONITORING WELL LOCATIONS</b>
Project 04516-3	February 2014
Fig. 2-1

- MONITORING WELL WITH SOIL VAPOR SAMPLE PORT INSTALLED BY GEI, JANUARY 2007 - JANUARY 2008
- MONITORING WELL INSTALLED BY SANBORN HEAD ASSOCIATES, 2002
- MONITORING WELL INSTALLED BY GEOINSIGHT, JUNE 2004
- MONITORING WELL INSTALLED BY GEI, MAY 2006
- DRIVEN POINT MONITORING WELL INSTALLED BY MADEP, MAY 2007
- MONITORING WELL INSTALLED PREVIOUSLY, DATE UNKNOWN
- PREVIOUSLY INSTALLED IRRIGATION WELL
- CHAIN LINK FENCE
- 138 ROOM NUMBER AT CAPUANO SCHOOL
- BOUNDARY OF COMMUNITY GARDENS
- 84 STREET ADDRESS
- MONITORING WELL SAMPLED DURING THIS REPORTING PERIOD

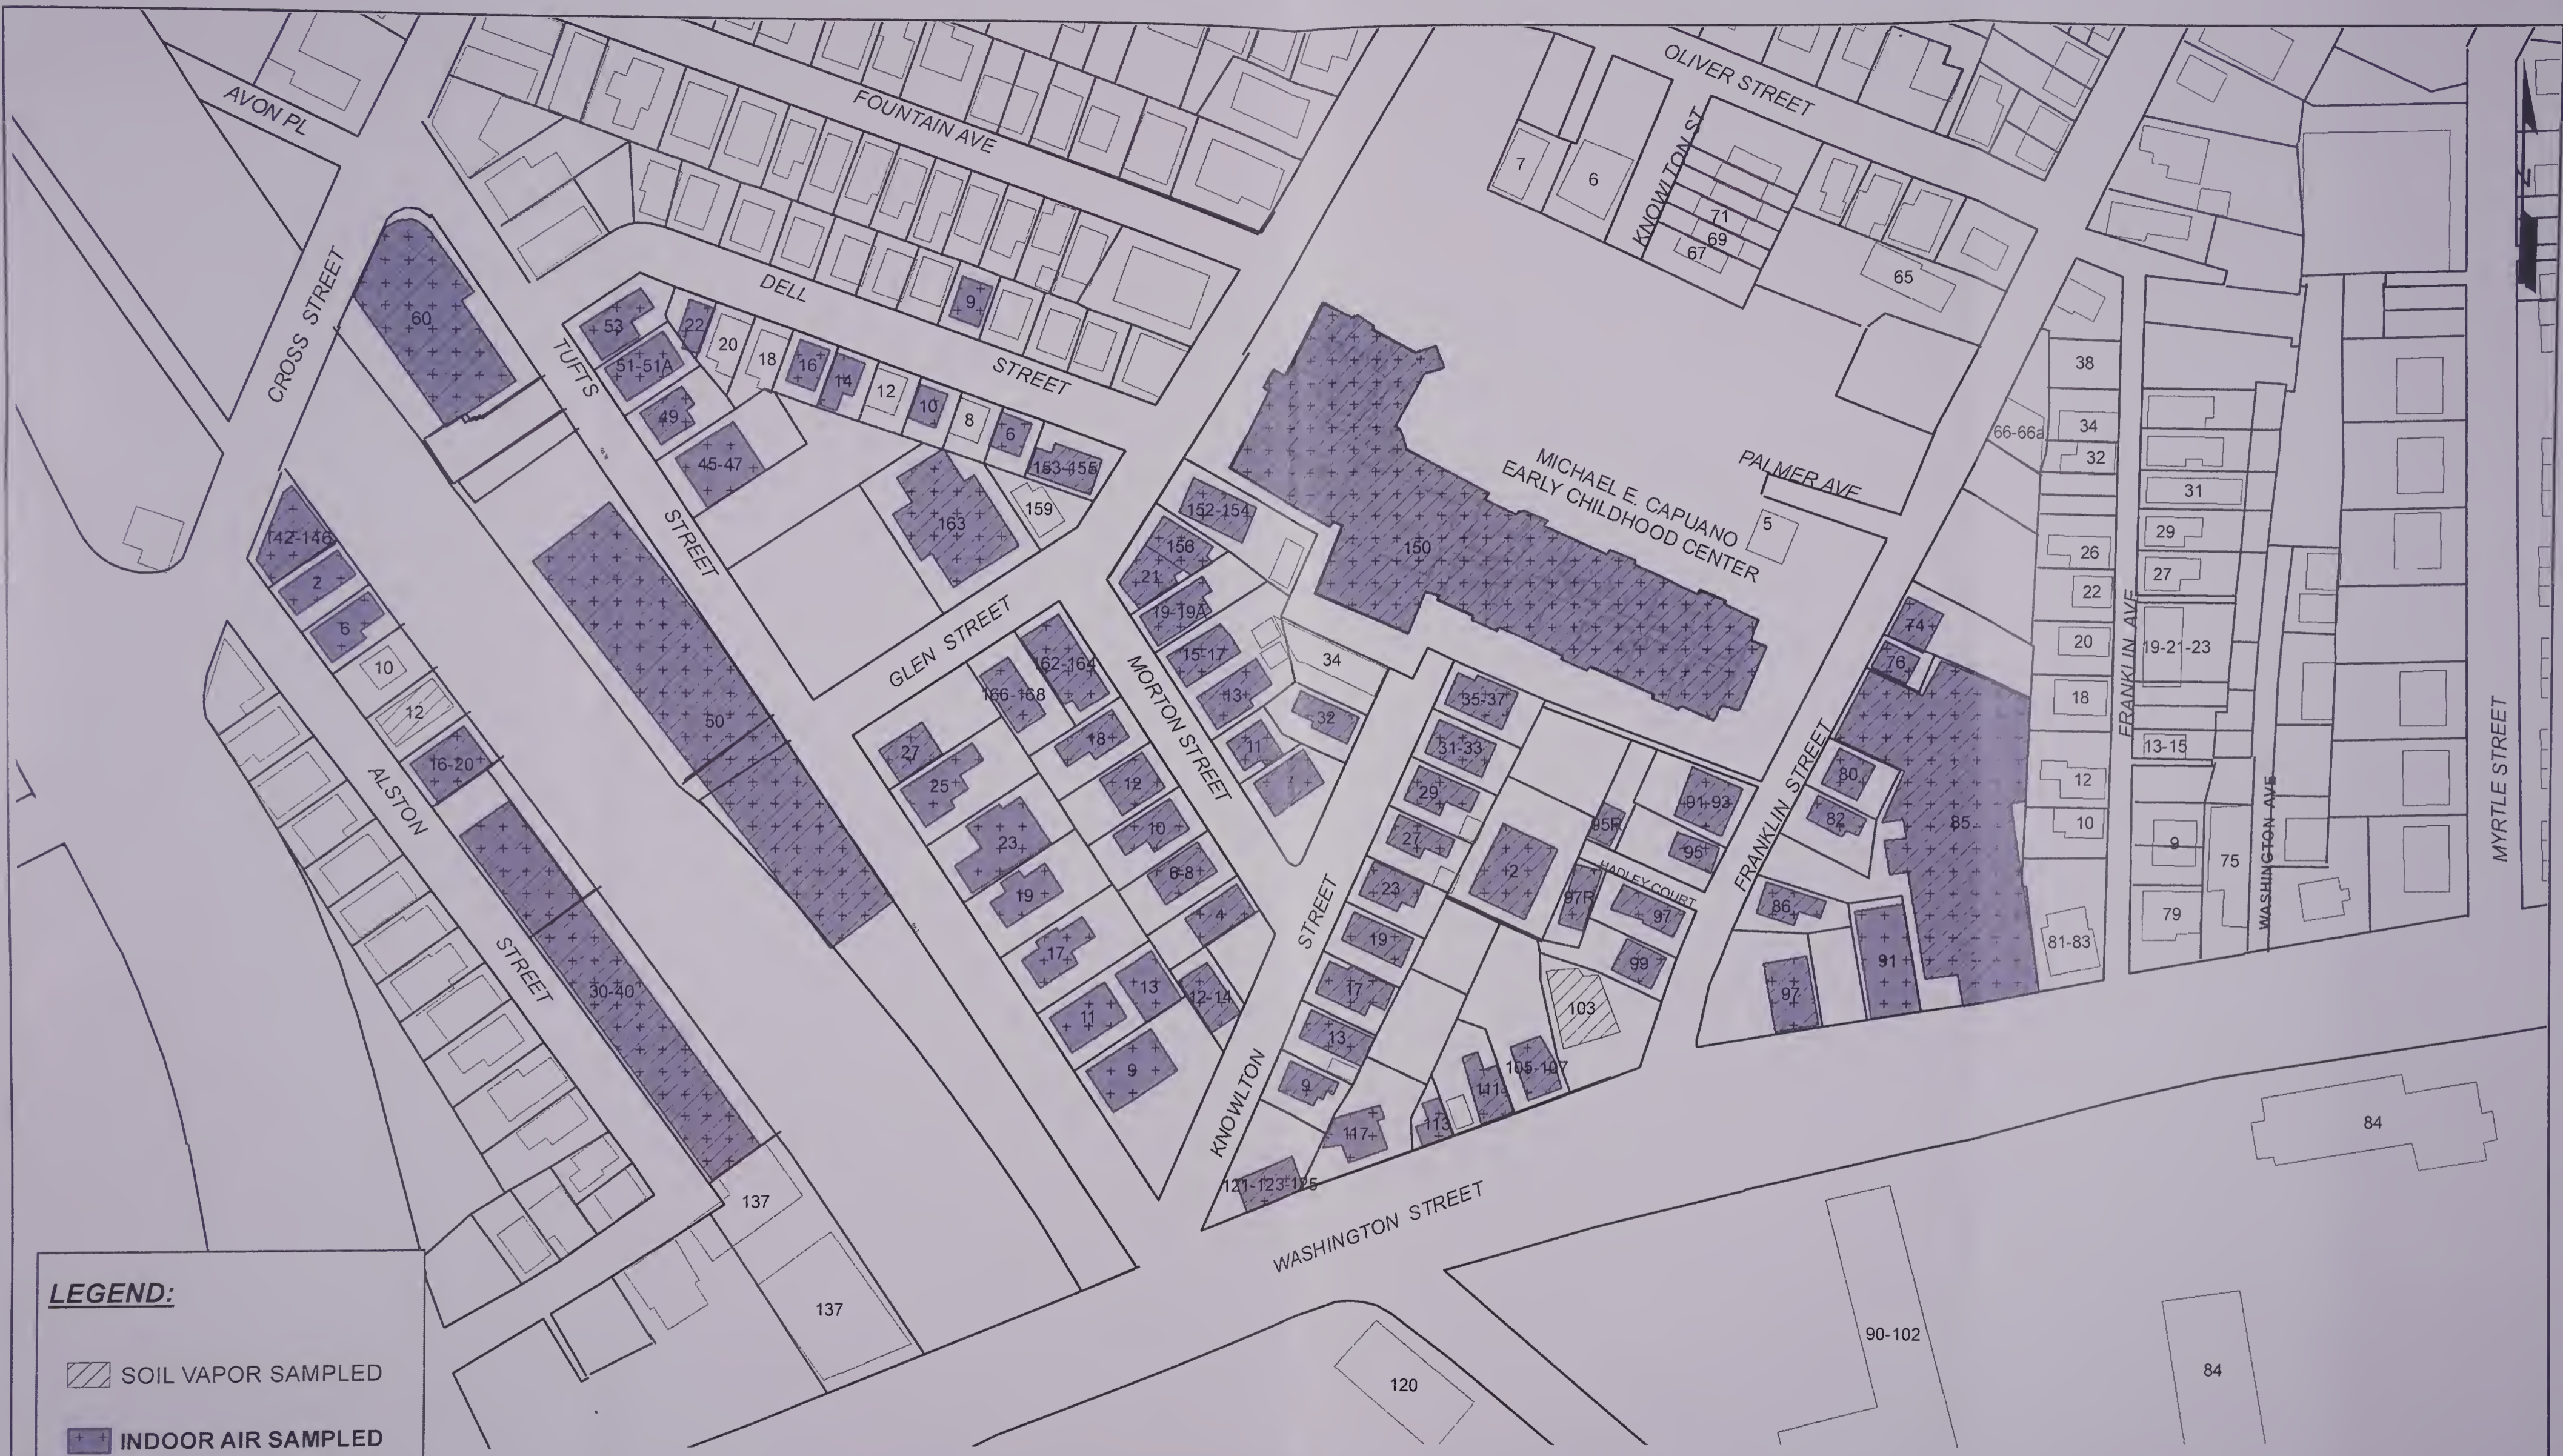
Fig. 2-2

SUB-SLAB SOIL VAPOR AND  
INDOOR AIR SAMPLING

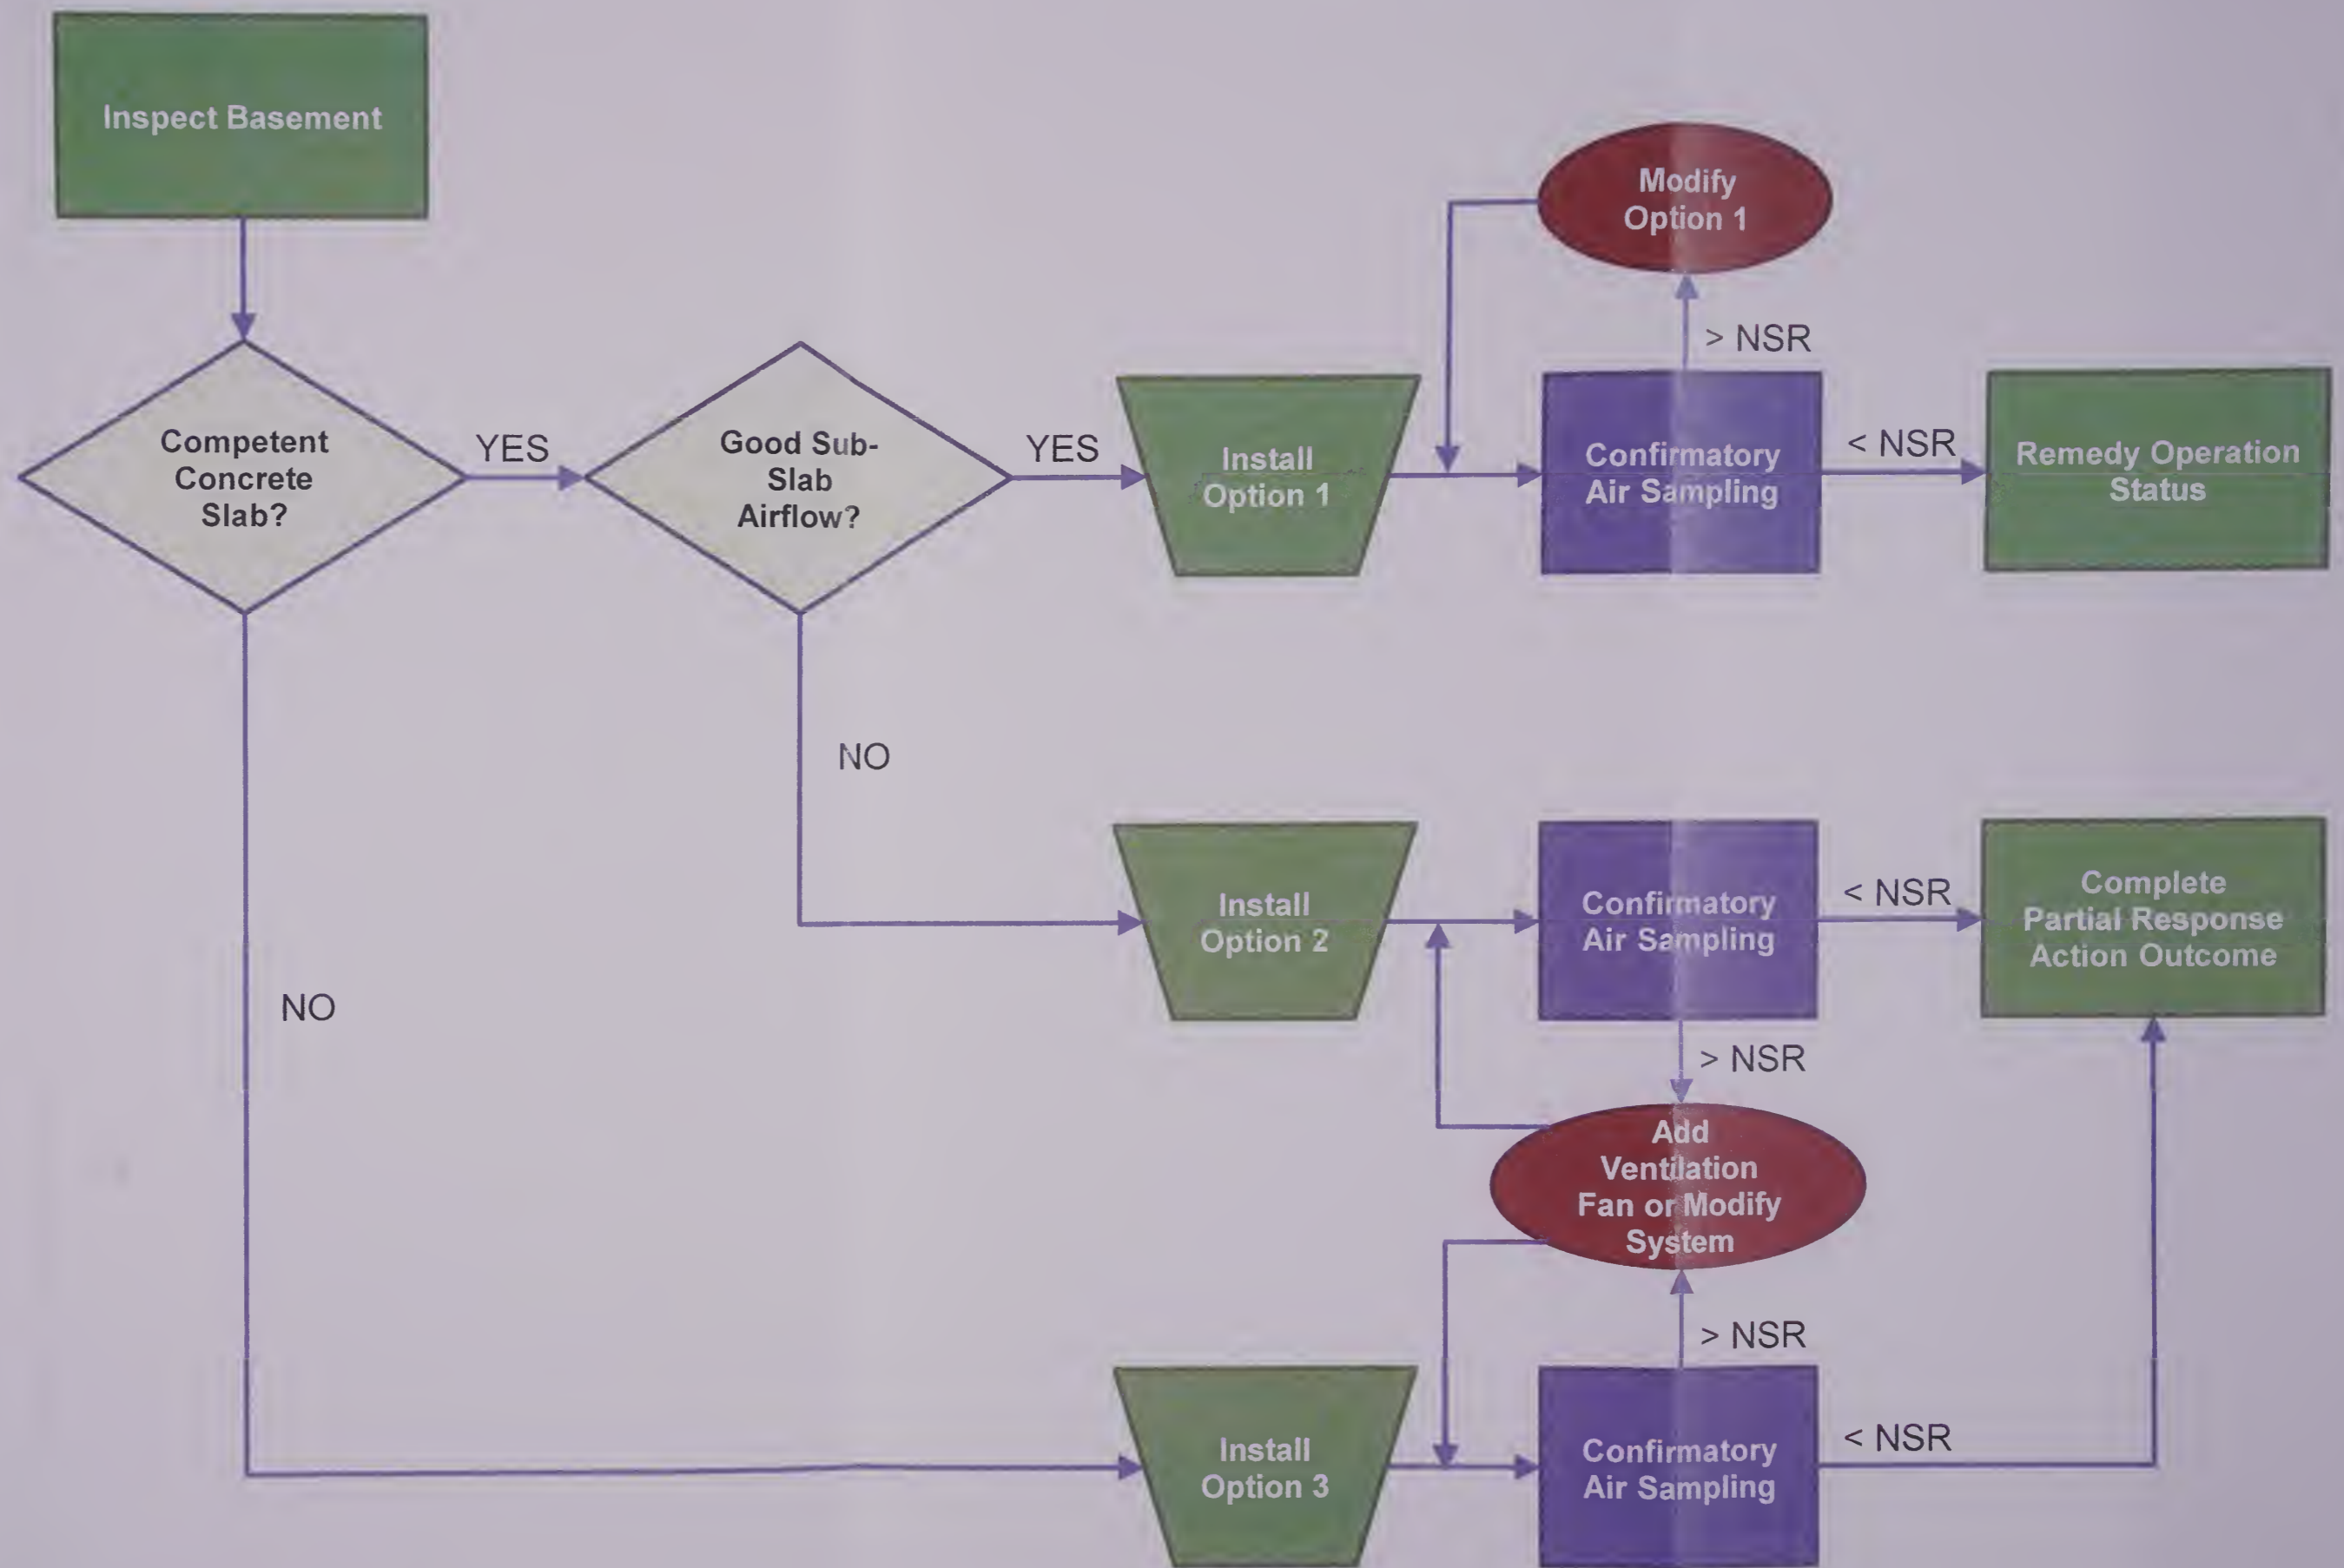
EPem MITIGATION FLOW CHART
UniFirst Corporation Wilmington, Massachusetts	Project 04516-3

The decision-making process for selecting a conceptual design based on Site-specific conditions is illustrated in Fig. 4-2. Table 4-1 identifies the design option for each EPEM currently installed and the primary engineering components of each.

**Option 3 (New Slab Installation):**

- 1. Incompetent concrete slab
- 2. Silt/clay sub-grade (poor sub-slab air flow)

- Option 2 – Vapor Trench: The vapor trench option consists of a sub-slab venting system installed in a shallow trench around the interior basement perimeter, cement stucco applied to the walls, and an epoxy vapor barrier applied to the slab and stucco walls. The trench is backfilled with crushed stone and finished with approximately three inches of new concrete to meet the existing slab surface. This option is installed in buildings with poor sub-slab air flow, a competent concrete slab, and a fieldstone and/or brick foundation. Sub-slab vapors are vented through a piping network that exits the building envelope at the sill elevation and terminates above the eave line of the roof.

- Option 3 – New Slab: The new slab installation option consists of installing a new concrete slab, a sub-slab vapor barrier, and a floor venting system; applying cement stucco to the walls; and applying an epoxy vapor barrier to the new slab and stucco walls. This option is installed in buildings with poor sub-slab air flow, an incompetent concrete slab, and a fieldstone and/or brick foundation. As with Option 2, sub-slab vapors are vented through a piping network that exits the building envelope at the sill elevation and terminates above the eave line of the roof.
